Quality Assurance and Source Inspection

Contract #: 04-0120F4Cty: SF/ALA Rte: 80 PM: 13.2/13.9File #: 1.28**WELDING INSPECTION REPORT****Resident Engineer:** Casey, William**Address:** 333 Burma Road**City:** Oakland, CA 94607**Report No:** WIR-028112**Date Inspected:** 06-Aug-2012**Project Name:** SAS Superstructure**OSM Arrival Time:** 700**Prime Contractor:** American Bridge/Fluor Enterprises, a JV**OSM Departure Time:** 1930**Contractor:** American Bridge/Fluor Enterprises, a JV**Location:** Job Site**CWI Name:** As noted below**CWI Present:** Yes No**Inspected CWI report:** Yes No N/A**Rod Oven in Use:** Yes No N/A**Electrode to specification:** Yes No N/A**Weld Procedures Followed:** Yes No N/A**Qualified Welders:** Yes No N/A**Verified Joint Fit-up:** Yes No N/A**Approved Drawings:** Yes No N/A**Approved WPS:** Yes No N/A**Delayed / Cancelled:** Yes No N/A**Bridge No:** 34-0006**Component:** SAS OBG**Summary of Items Observed:**

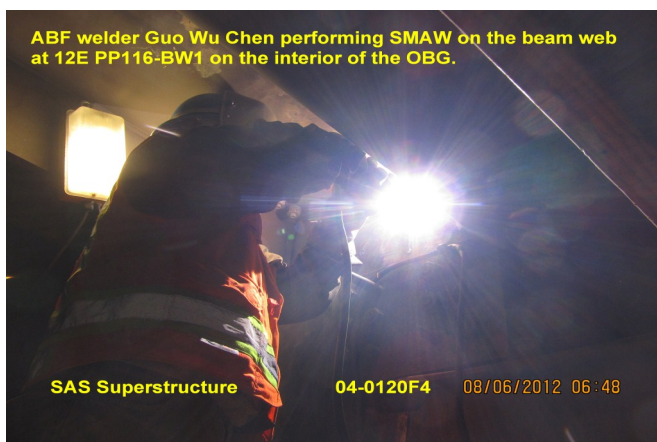
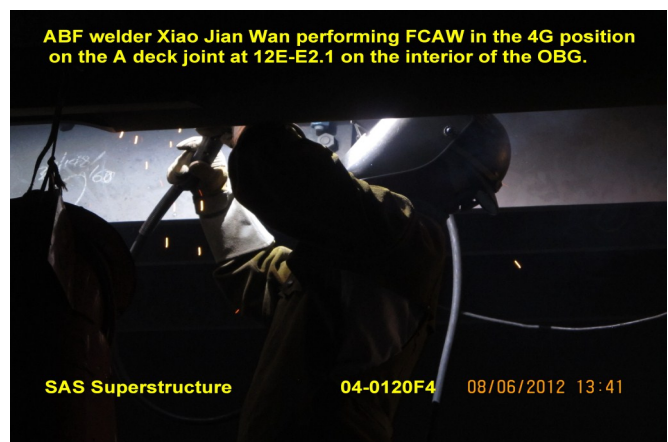
This QA Inspector randomly observed ABF/JV qualified welder Xiao Jian Wan #9677 continuing to perform production welding using the Flux Core Arc Welding (FCAW) process in the 4G overhead position on the A deck joint at 12E-E2.1 on the interior of the OBG. The splice joint was preheated to greater than 200 degrees Fahrenheit using Miller Proheat 35 Induction Heating System with the heater blanket located at the opposite side of the deck prior/during welding. This QA Inspector observed QC Inspector Salvador Merino verify prior to the start of welding operations, that the minimum preheat temperature as per the approved WPS was established; and afterwards verified that the welding parameters (Amps, Volts and Travel Speed) were in accordance with ABF-WPS-D1.5-1-3110-4. This QA Inspector made subsequent observations throughout the shift to monitor quality and noted the work at this location is in progress and appeared to be in general conformance with the contract specifications.

the specifications and ABF/JV qualified welder Guo Wu Chen #1556 was observed performing the Shielded Metal Arc Welding (SMAW) Process in the 3G vertical position while the QC Inspector monitored the welding and the parameters as they pertained to ABF-WPS-D1.5-1040A. The welder was observed grinding and blending the start/stop edges of the work utilizing a small disc grinder and compressed air in between passes as QC measured the inter-pass temperatures with an infra-red temperature gun. This QA Inspector made subsequent observations throughout the shift to monitor quality and noted the work at this location is in progress and appeared to be in general conformance with the contract specifications.

This QA Inspector randomly observed the in progress welding on 12E PP117-BW1/SP1/SP2 on the interior of the OBG. ABF/JV qualified welder Jia Yan #1571 was observed performing the SMAW process in the 3G vertical position. Prior to welding QC Inspector Salvador Merino was observed monitoring the pre-heating of the joint and the parameters as they pertain to ABF-WPS-D1.5-1040A. This QA Inspector verified that the 3.2mm electrodes were stored in an electrically heated thermostatically controlled oven after removal from the sealed containers. The exposure limits of the electrodes appeared to comply with the minimum storage oven temperature of 120 degrees Celsius as per the contract documents. The welding parameters and surface temperatures were verified by the QC inspector's utilizing a Fluke 337 clamp meter to measure the electrical welding parameters. The welder was observed grinding and blending the start/stop edges of the work utilizing a small disc grinder and compressed air in between passes as QC measured the inter-pass temperatures with an infra-red temperature gun. Upon completion of welding on face A, the QC Inspector performed a Magnetic Particle (MT) Inspection of the back-gouged site and found no rejectable indications. Welding commenced on face B and progressed throughout the remainder of the shift. This QA Inspector made subsequent observations throughout the shift to monitor quality and noted that the production welding at this location was in progress and appeared to be in general conformance with the contract documents.
